## Technician Bulletin—Troubleshooting for CK2555 & CK2575

### Passthrough Dishwashers

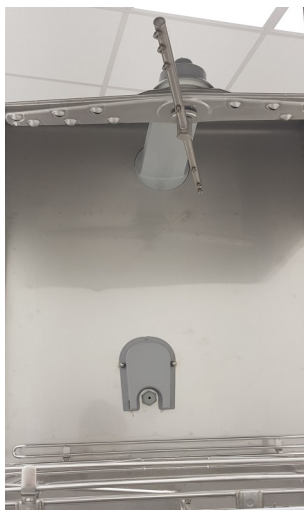
Pic 1

The air trap is located on the back wall inside the washing chamber (Pic 1). A build up of dirt behind the plastic protection means the machine may either over or under fill. (Pic 2)

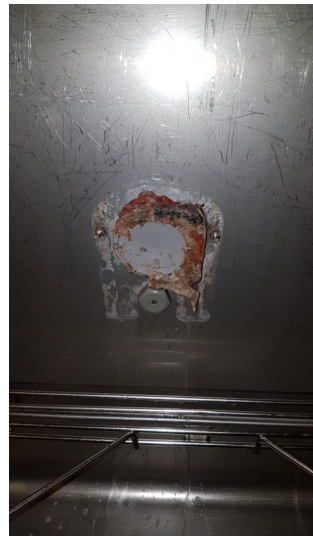
Pic 2

A common problem, that our customers report, is due to poor maintenance of the air trap.
